How to Avoid Corrosion and Cracking of Plates

The Negative Effects of Using Non-Alfa Laval Adhesives

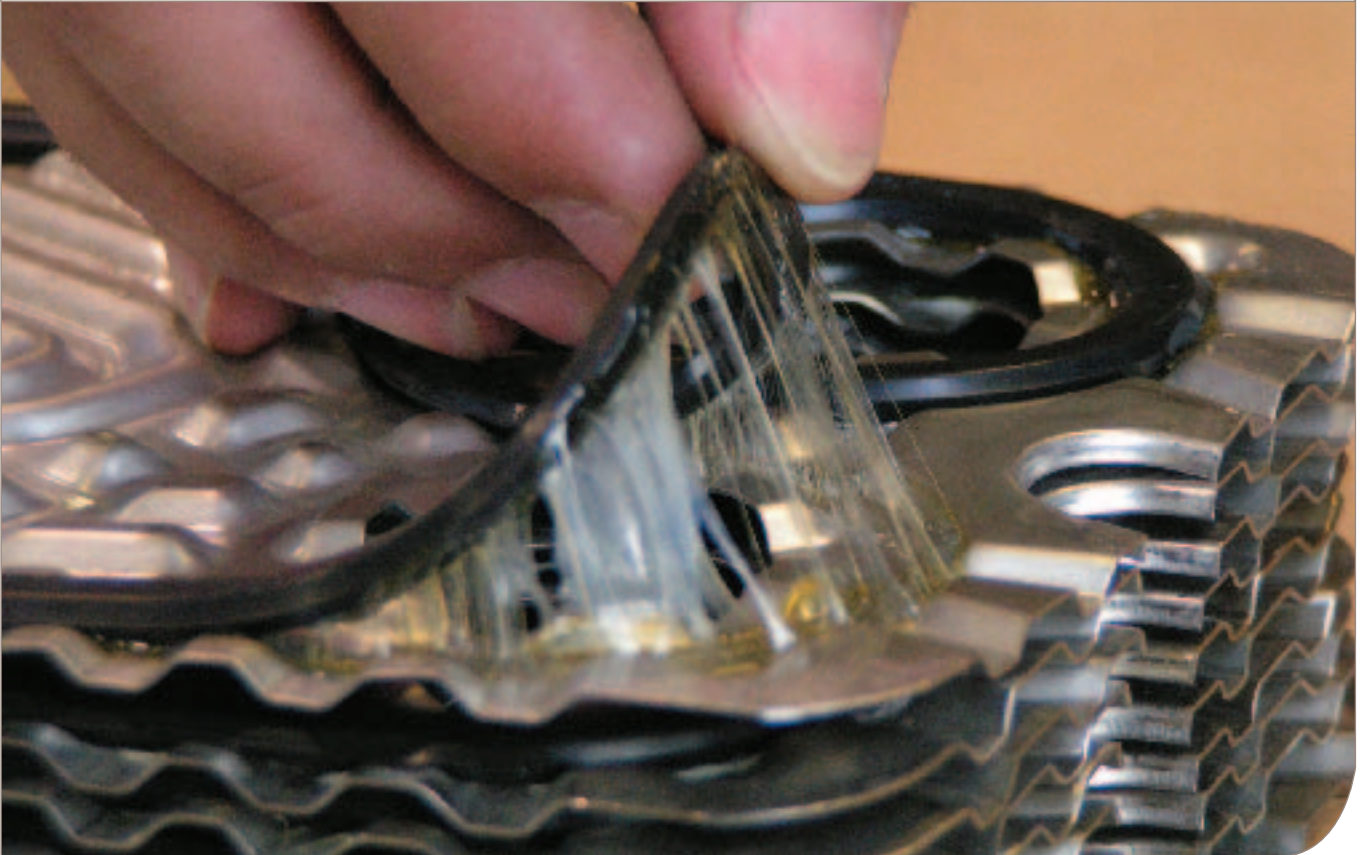
Alfa Laval strongly recommends that only approved adhesives are used. This will make sure that potentially damaging elements are not conflicting with the products.

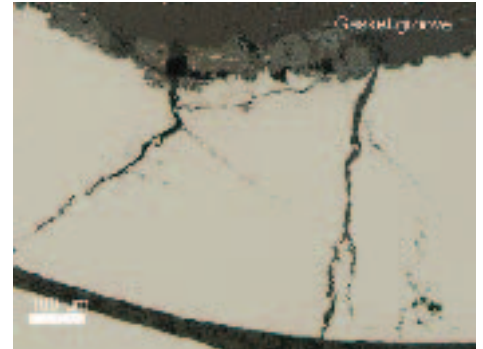
Stress corrosion cracks in the V85 plate. The dark grey objects on the upper side of the plate piece are corrosion products.

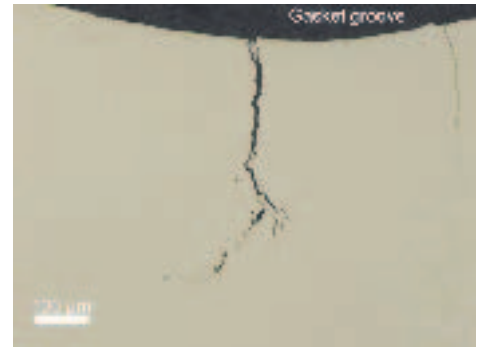
Stress corrosion cracks in one of the V170 plates.

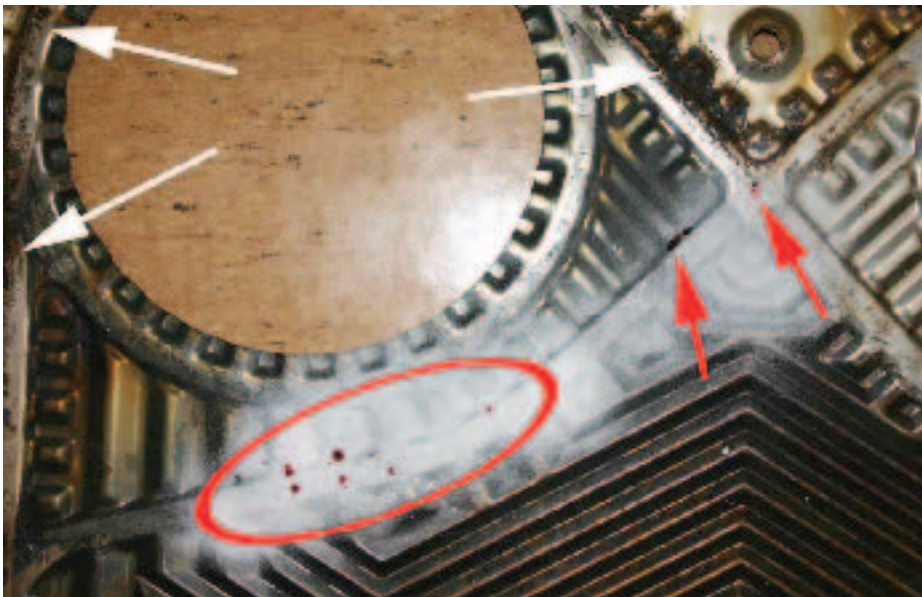
V85 plate. In addition to the obvious and severe corrosion and cracking along the outer gasket groove (marked with arrows), the use of red dye penetrant revealed numerous perforations along the gasket diagonal, shown as red spots (highlighted by the red arrows and in the encircled area.)

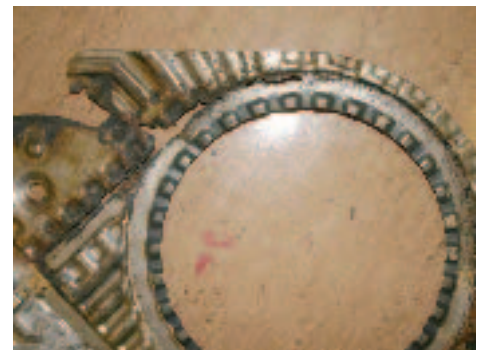
V85 plate. The damages are mainly located in the gasket grooves.
